What Will Be Covered:

- **The Steps To Taken To Diagnose Problem Vehicles**
- **Ford Alternator Problem**
- **P0420 DTC Issue**
- **GM Throttle Body DTC**
- **Chevy Network Problem**

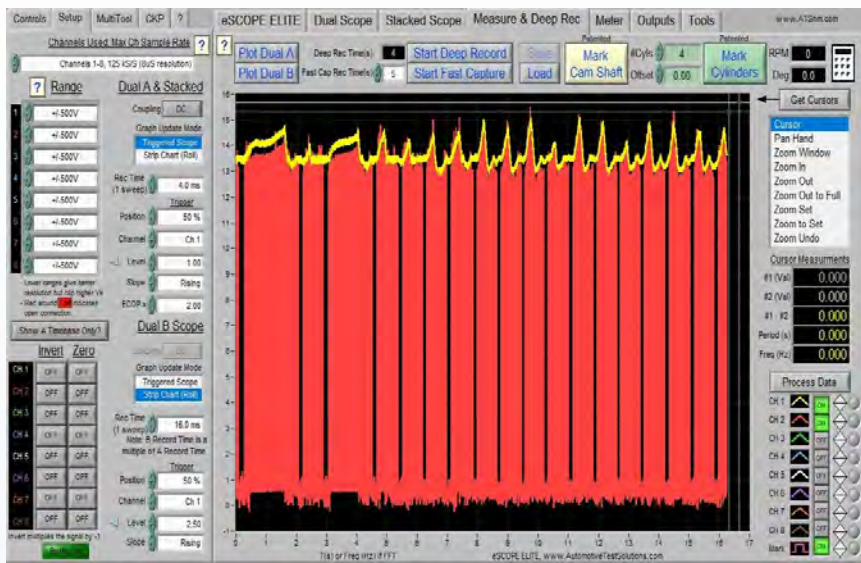
Alternator Problem...
Yellow Charging Voltage
Red Control Circuit Duty Cycle

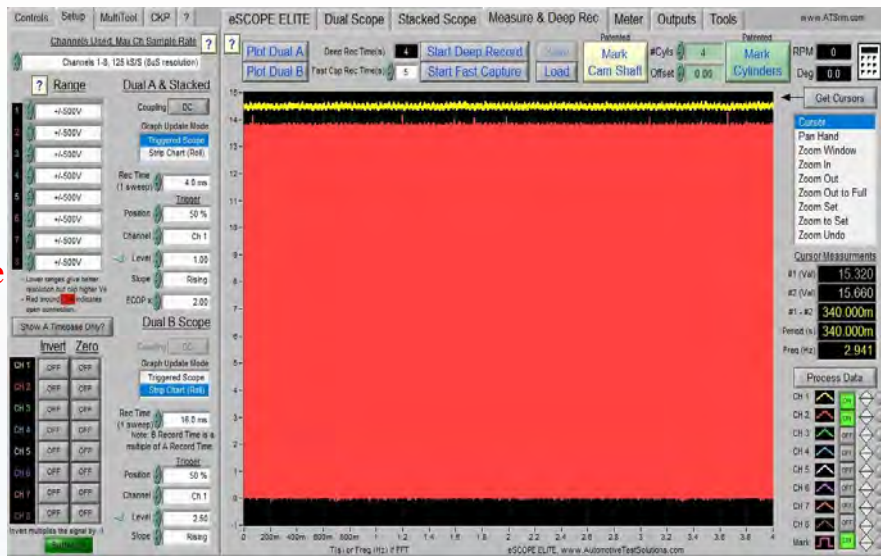
New Ford Alternator Fixed...
Yellow Charging Voltage
Red Control Circuit Duty Cycle

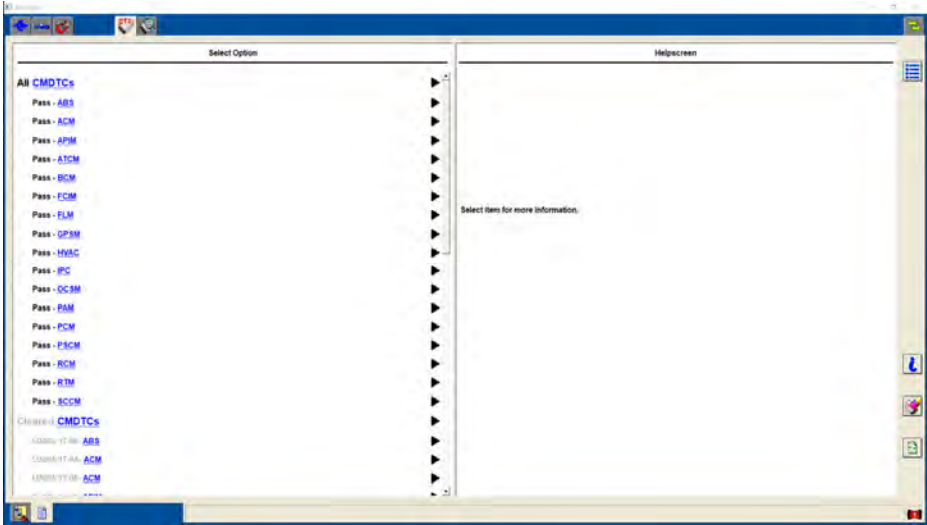
Fixed... No DTCs

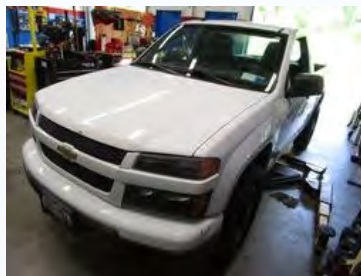
Complaint: Stabilitrac and ABS message displayed on dash.

Code: U1000 - Class 2 Data BUS Code ABS and Instrument Cluster & voltage codes in BCM and TPMS

Researching the system showed that the BCM monitors voltage over multiple modules and is also the common "HUB" for most modules on the Class 2 BUS. Tested Powers and grounds at BCM checked out OK.

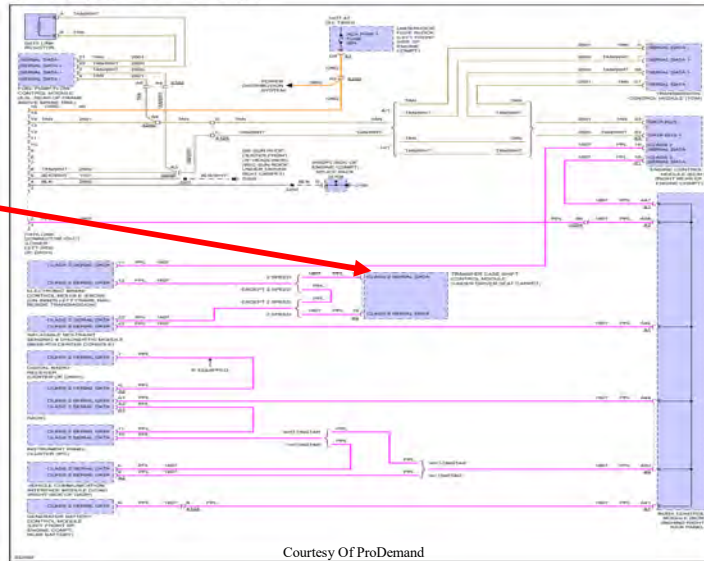
Fig 1: Computer Data Lines Circuit

Traced wires with voltage out of range back to Transfer Case control module.

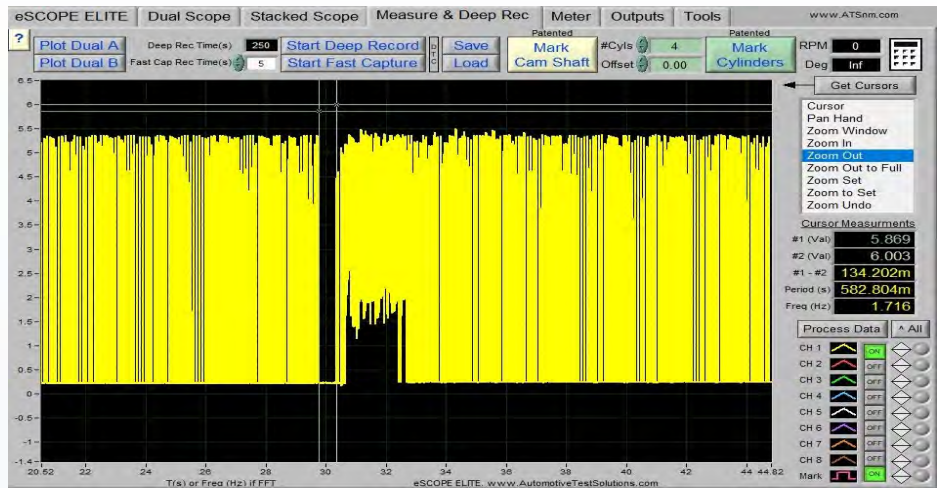
Connected a labscope at DLC to check waveform on Class 2 data BUS and found 0 - 5v waveform. The voltage needs to be 7 volts - something is pulling it down. Went to next easiest module (ABS) and scoped both Class 2 wires at the module.

Found a break in the data along with two different voltage ranges at the wires.

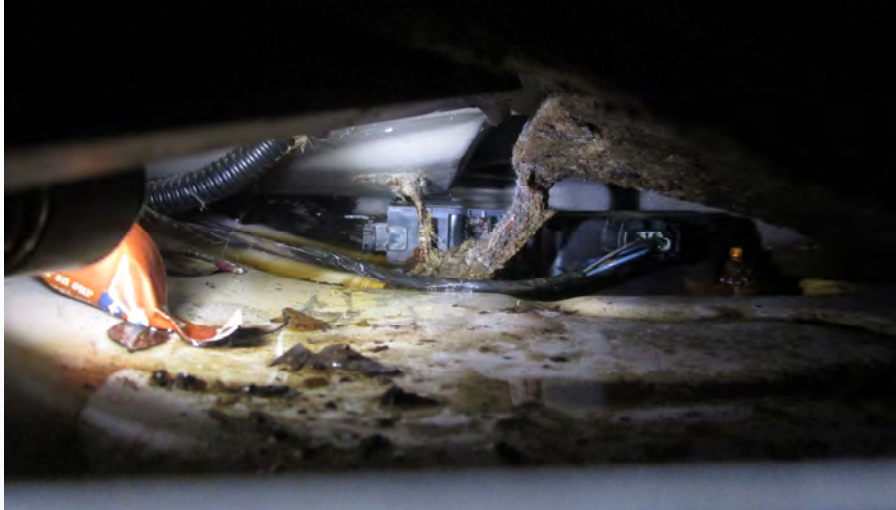
Problem: Transfer Case module under driver's seat submerged in water.
